# Environmental Projects: Volume 4

## Asbestos Survey

Goldstone Deep Space Communications Complex

Jet Propulsion Laboratory  
California Institute of Technology  
Pasadena, California

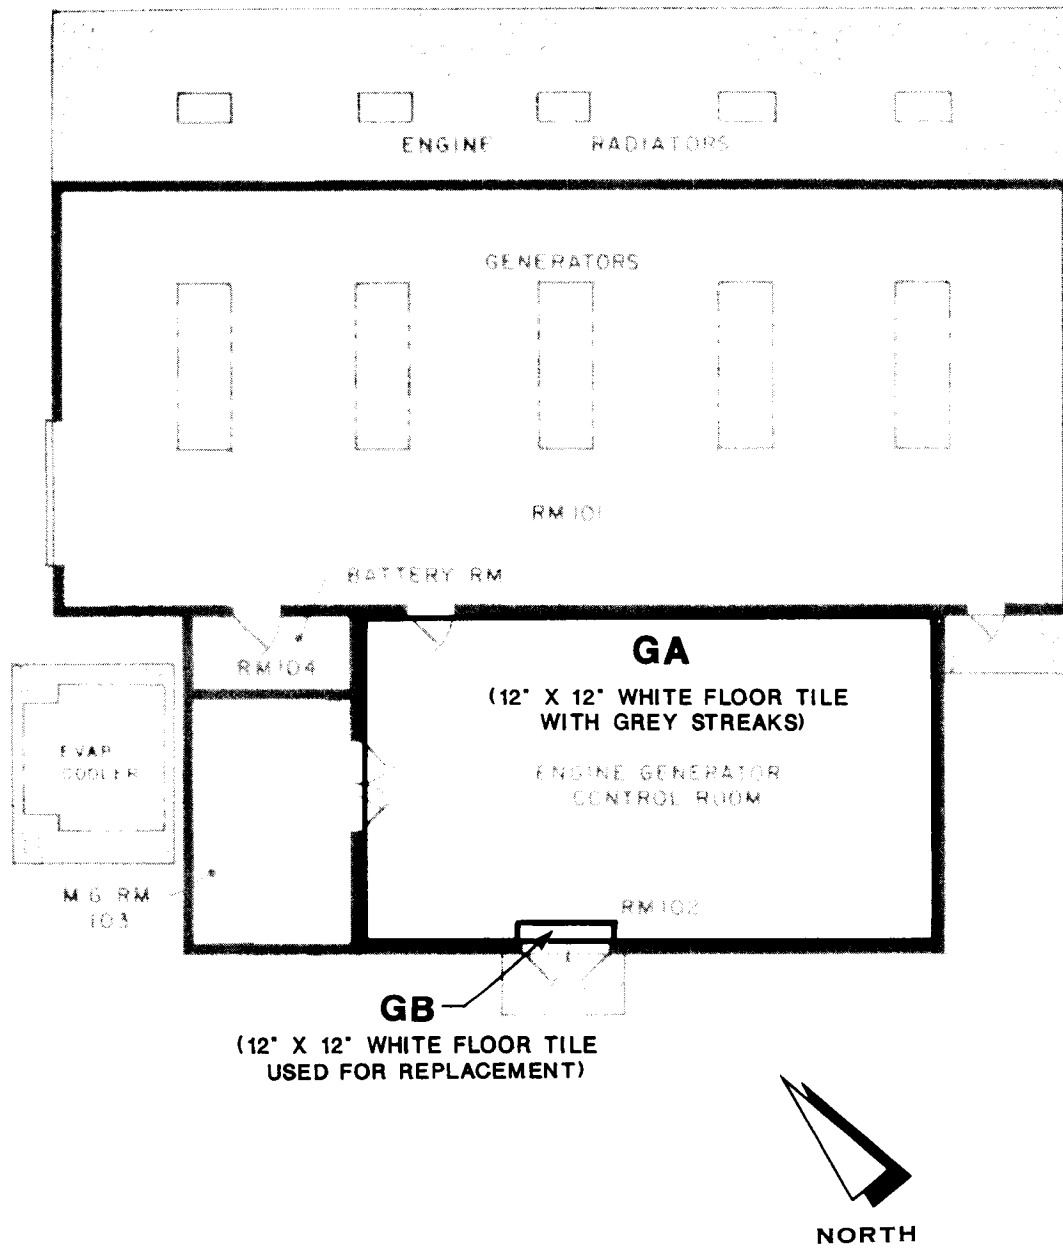
Figure 18. Echo Site: Generator Building G-24.

Comments: 12 X 12 in. WHITE WITH GRAY STREAK TILE. SEE FIGURE 18

Comments: 12 X 12 in. WHITE WITH GRAY STREAK TILE USED FOR REPLACEMENT. SEE FIGURE 18

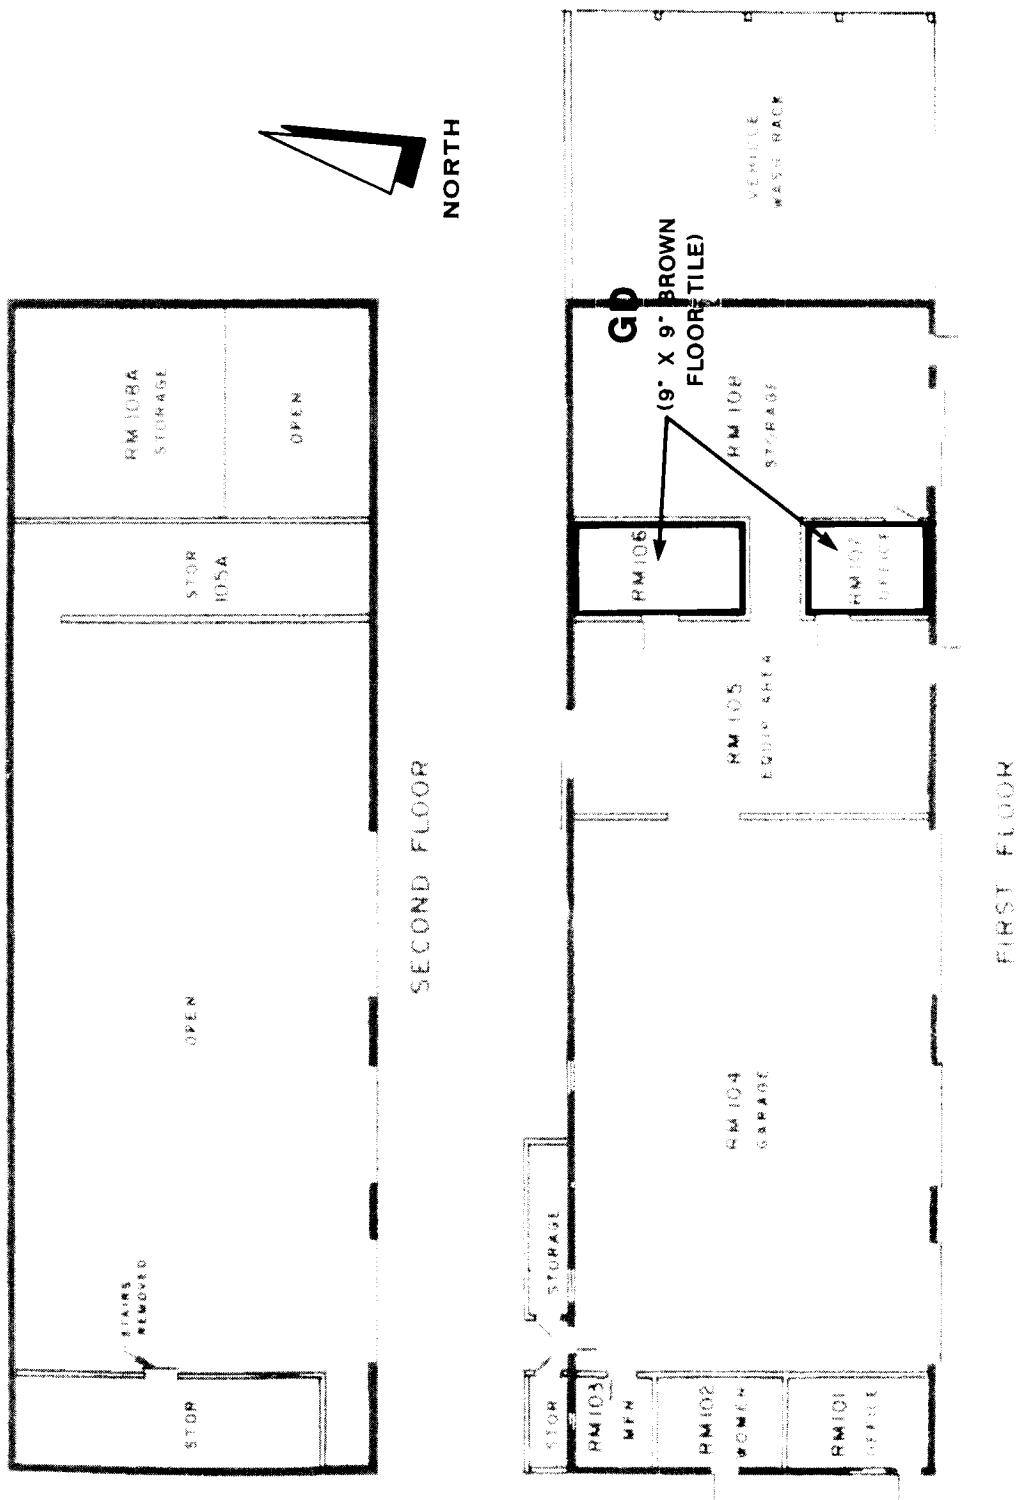
Figure 19. Echo Site: Transportation Maintenance Building G-25.

Comments: 9 X 9 in. BROWN TILE LIKE ROOM 124 IN BUILDING G-26. SEE FIGURE 19

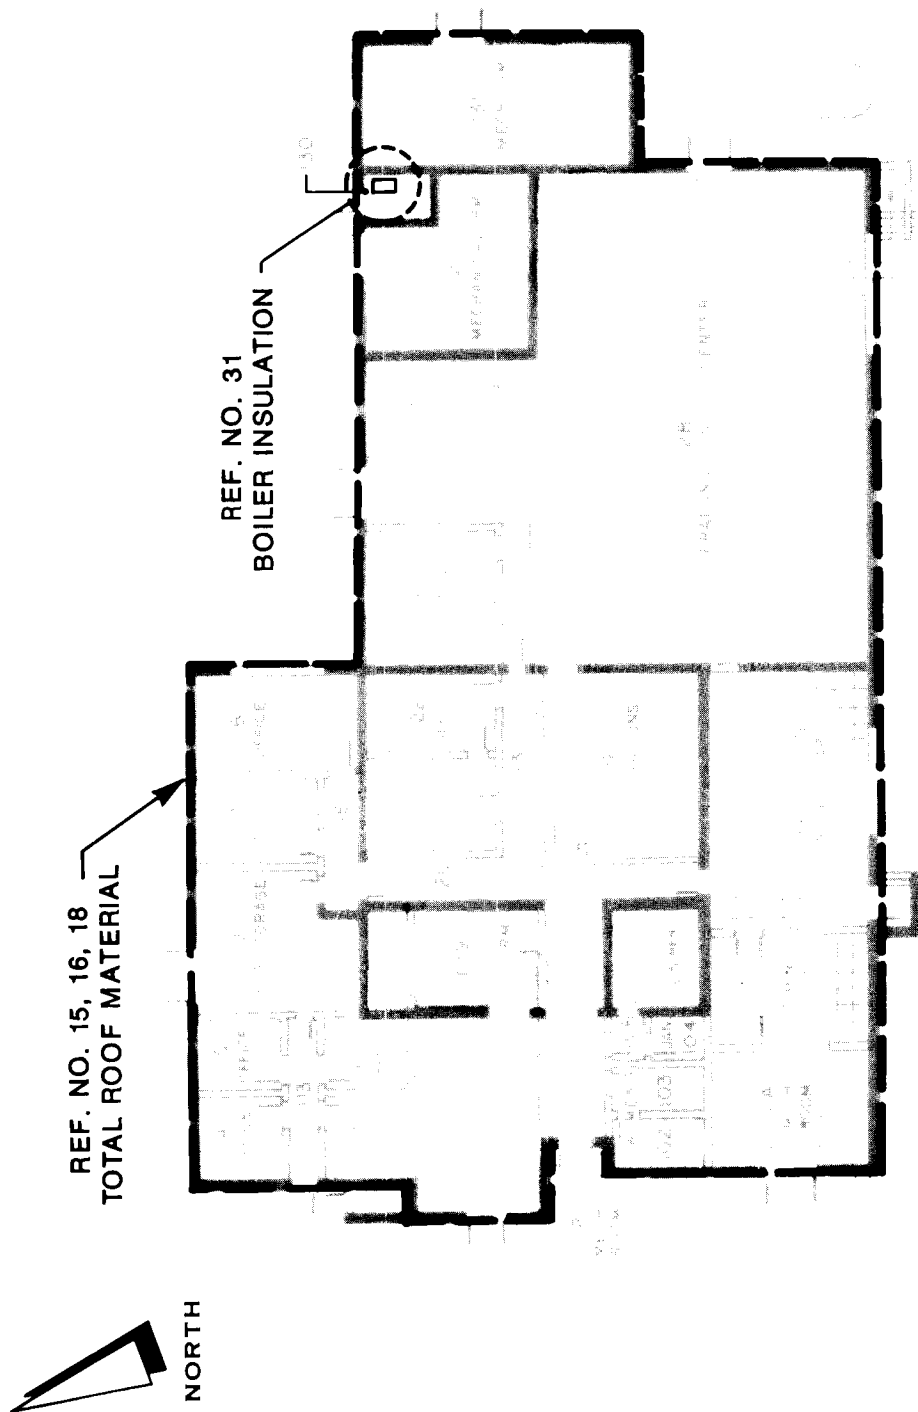
Figure 21. Echo Site: Control Building G-26.

Comments: BOILER ROOM ACCESSED FROM OUTSIDE AND IS IN A TIGHT SPACE. SEE FIGURE 21.

Comments: ROOF MATERIAL COVERED WITH TAR. SEE FIGURE 21

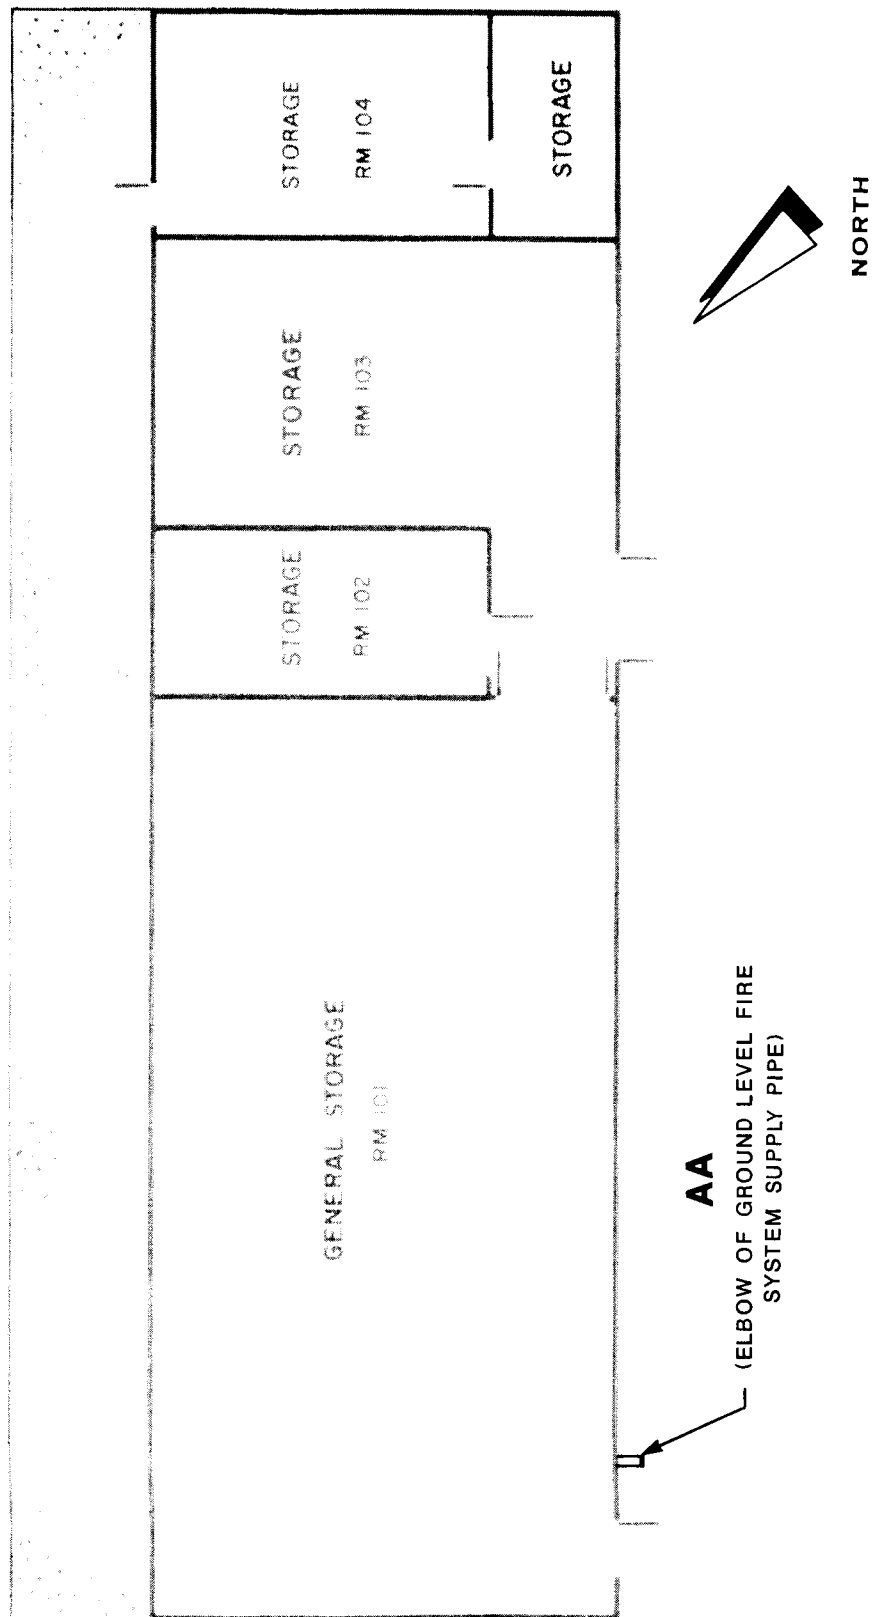
Figure 26. Echo Site: Office and Storage Building G-27.

Comments: ELBOW HARD CEMENTITIOUS MATERIAL WITH SOME ADDITIONAL USE  
EXTENDING AWAY FROM THE ELBOW. SEE FIGURE 26

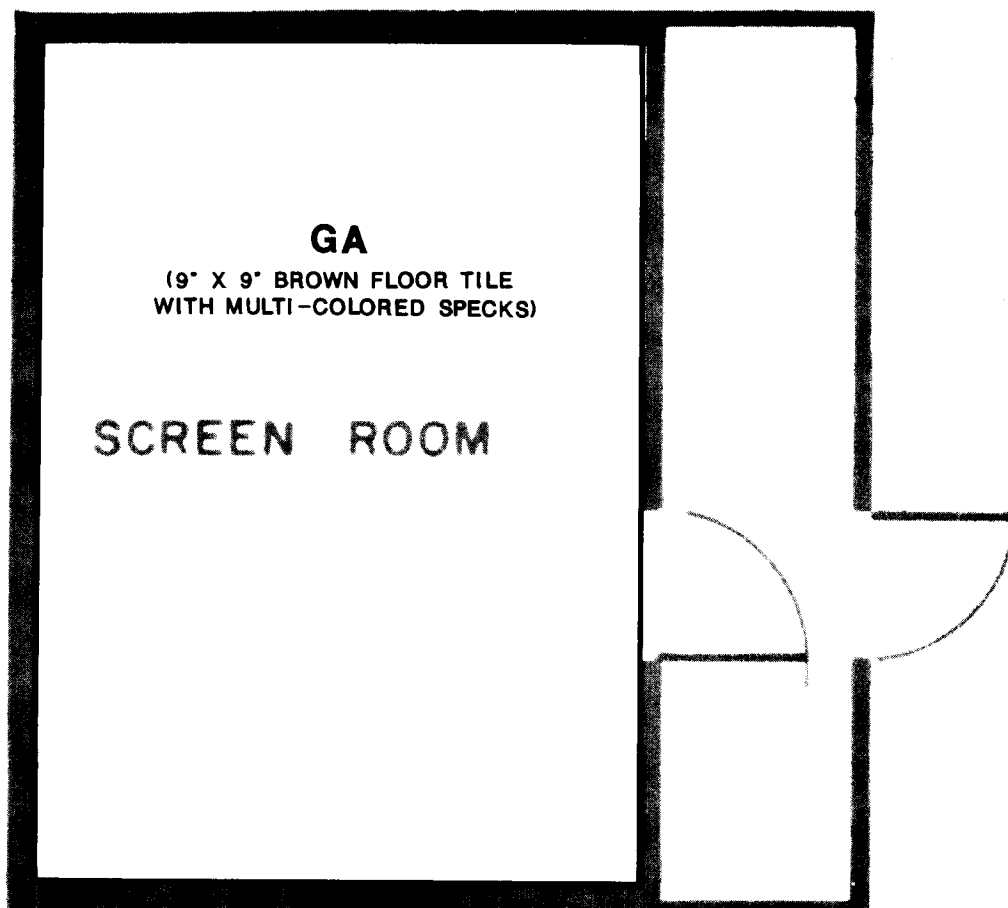
Figure 35. Echo Site: Collimation Tower Building G-36.

Comments: 9 X 9 in. BROWN TILE WITH MULTI-COLORED SPECKS. SEE FIGURE 35

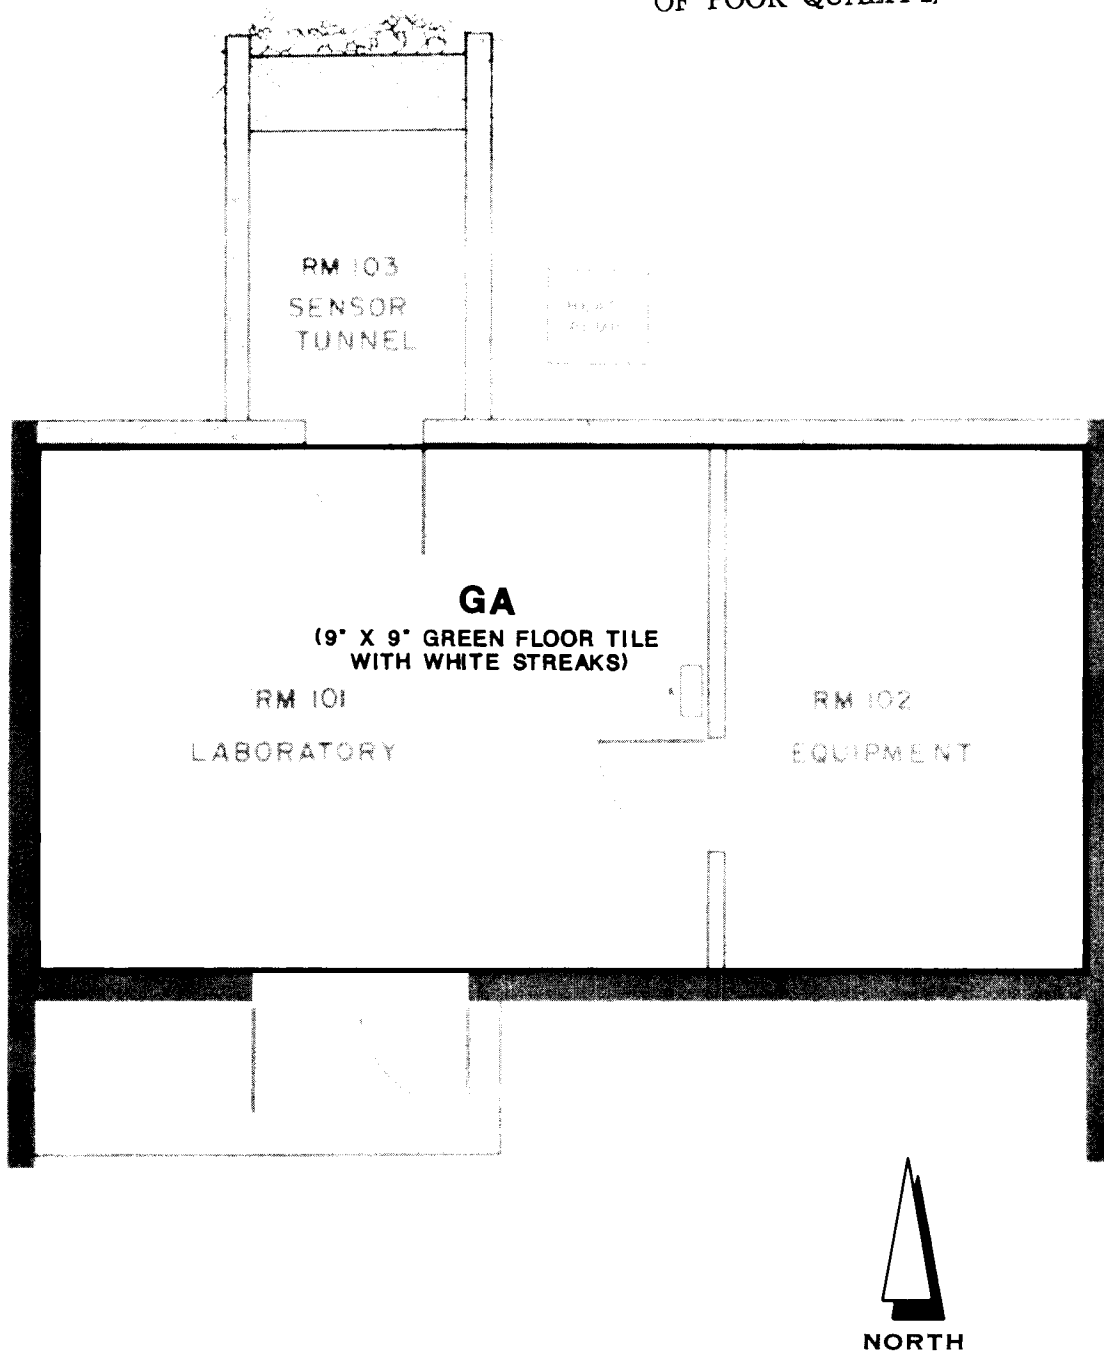
Figure 36. Echo Site: Seismic Laboratory Building G-37.

Comments: 9 X 9 in. GREEN TILE WITH WHITE STREAKS. SEE FIGURE 36

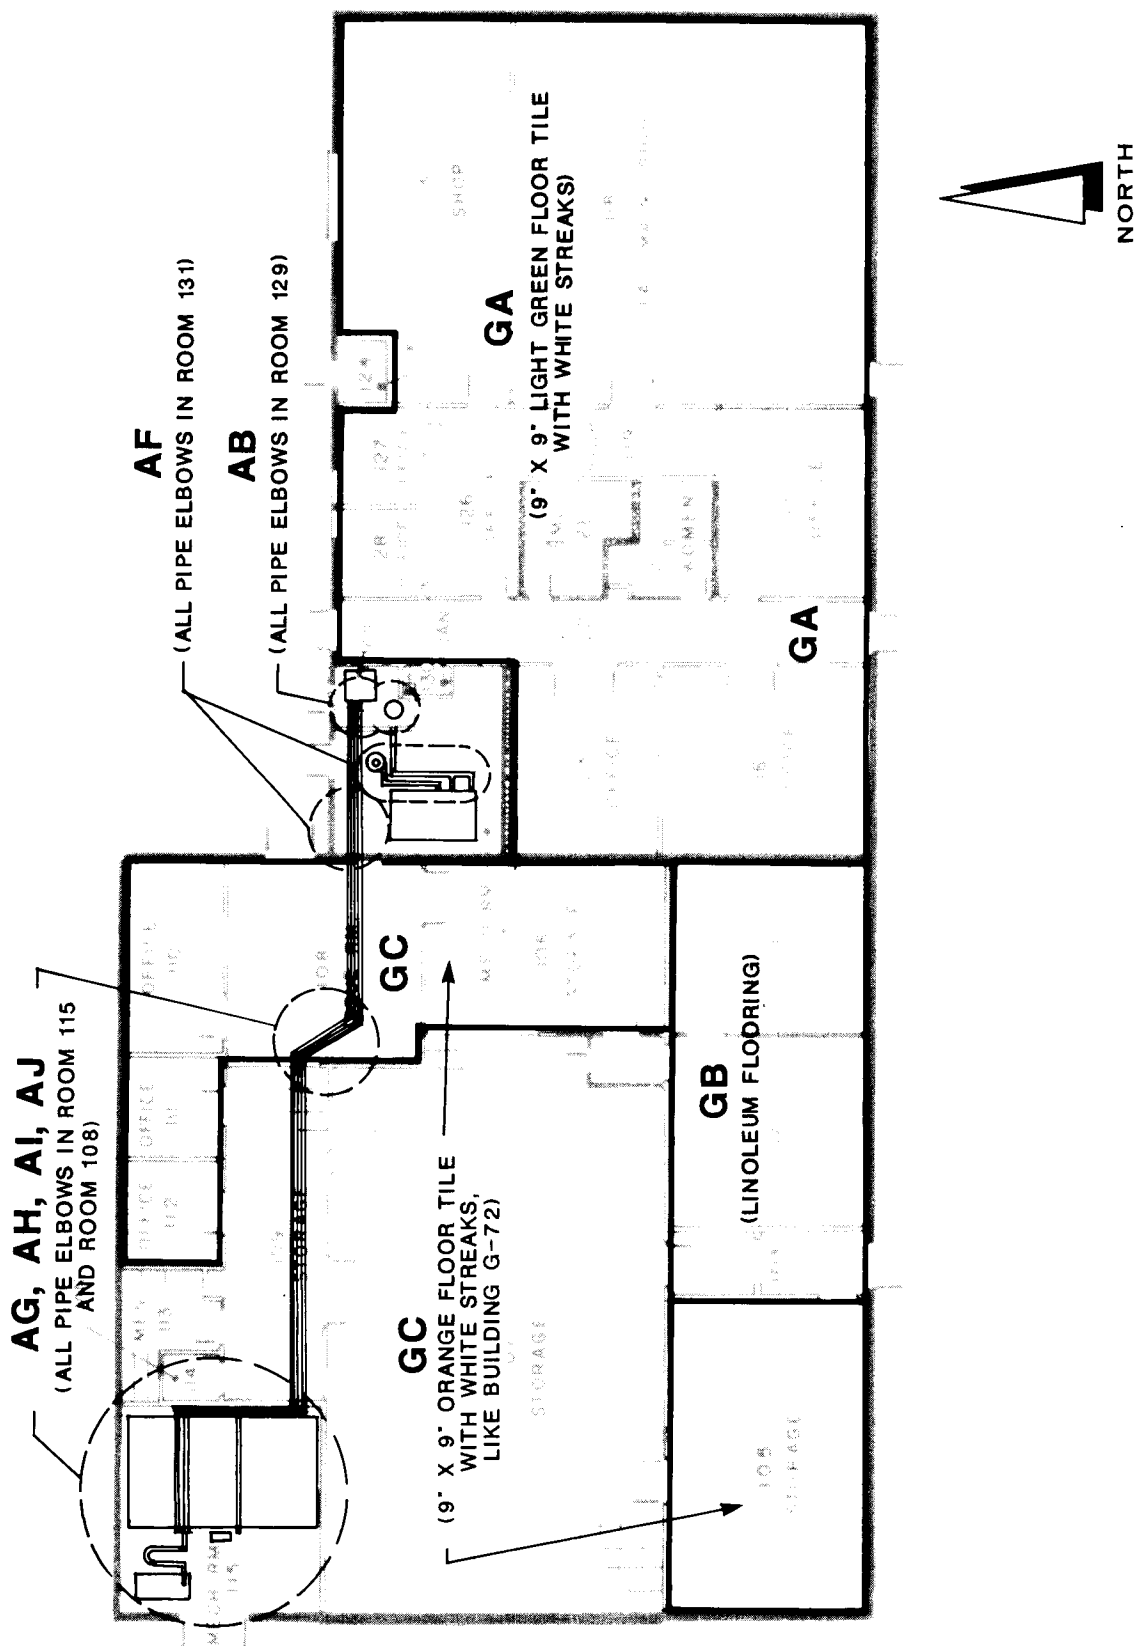
Figure 37. Echo Site: Network Laboratory and Maintenance Facility Building G-38.

Comments: ELBOW HARD CEMENTITIOUS MATERIAL. SEE FIGURE 37

Comments: HARD CEMENTITIOUS MATERIAL USED ON ELBOWS. SEE FIGURE 37

Comments: HARD CEMENTITIOUS ELBOW LAGGING. TOTAL OF 9 ELBOWS IN ROOM. SEE FIGURE 37

Comments: HARD CEMENTITIOUS MATERIAL ON PIPING ELBOW. SEE FIGURE 37

Comments: HARD CEMENTITIOUS MATERIAL ON PIPING ELBOW. TOTAL OF 7 ELBOWS IN ROOM. SEE FIGURE 37

Comments: HARD CEMENTITIOUS MATERIAL ON PIPING ELBOW. TOTAL OF 4 ELBOWS IN ROOM. SEE FIGURE 37

Comments: LINOLEUM SHEETING. SEE FIGURE 37

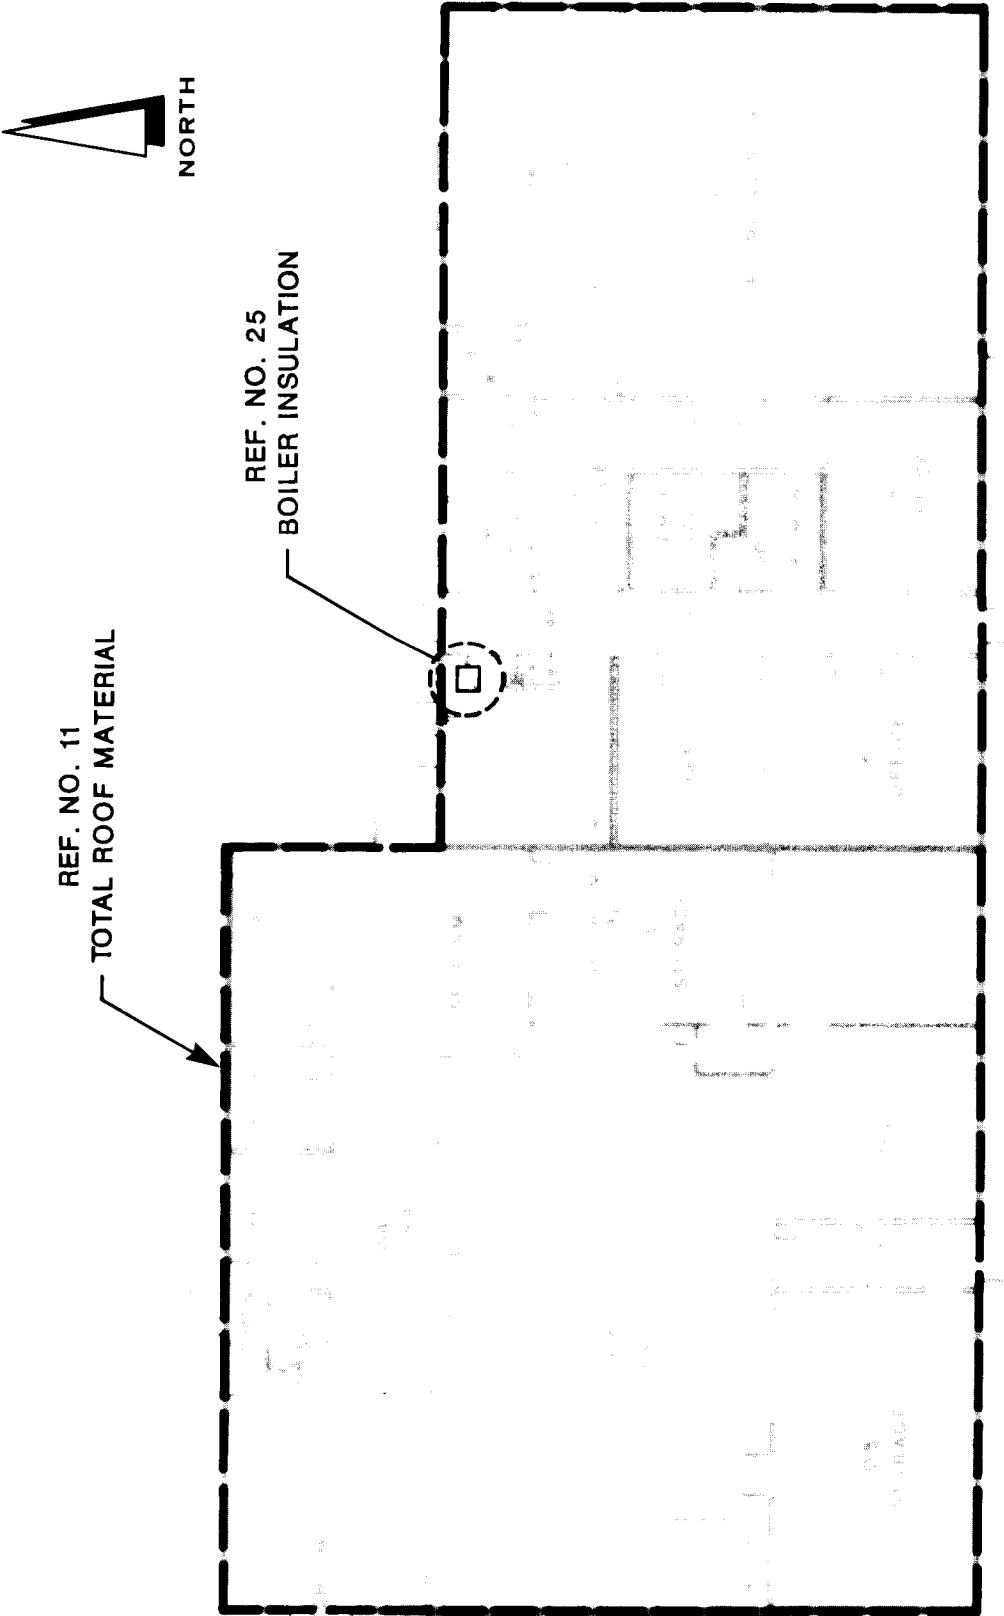
Figure 38. Echo Site: Network Laboratory and Maintenance Facility Building G-38.

Comments: BOILER ROOM ACCESSED FROM OUTSIDE AND IS IN A TIGHT SPACE.  
SEE FIGURE 38

Comments: ROOF MATERIAL COVERING OF TAR ON CONCRETE. SEE FIGURE 38

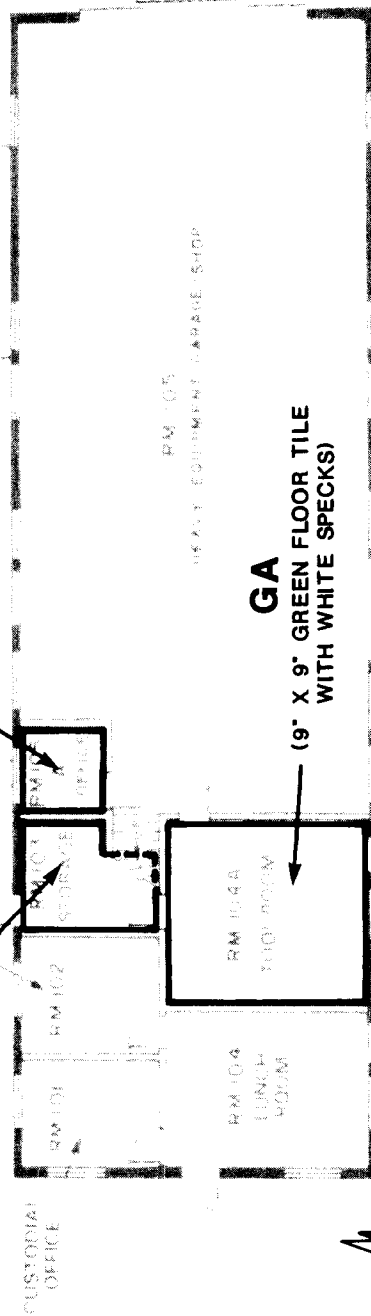
Figure 42. Echo Site: Garage Building G-42.

Comments: 9 X 9 in. GREEN TILE WITH WHITE SPECKS. SEE FIGURE 42

Comments: 9 X 9 in. WHITE TILE WITH GRAY AND BLACK MARBLE. SEE FIGURE 42

Comments: 9 X 9 in. WHITE TILE WITH SPECKLES. SEE FIGURE 42

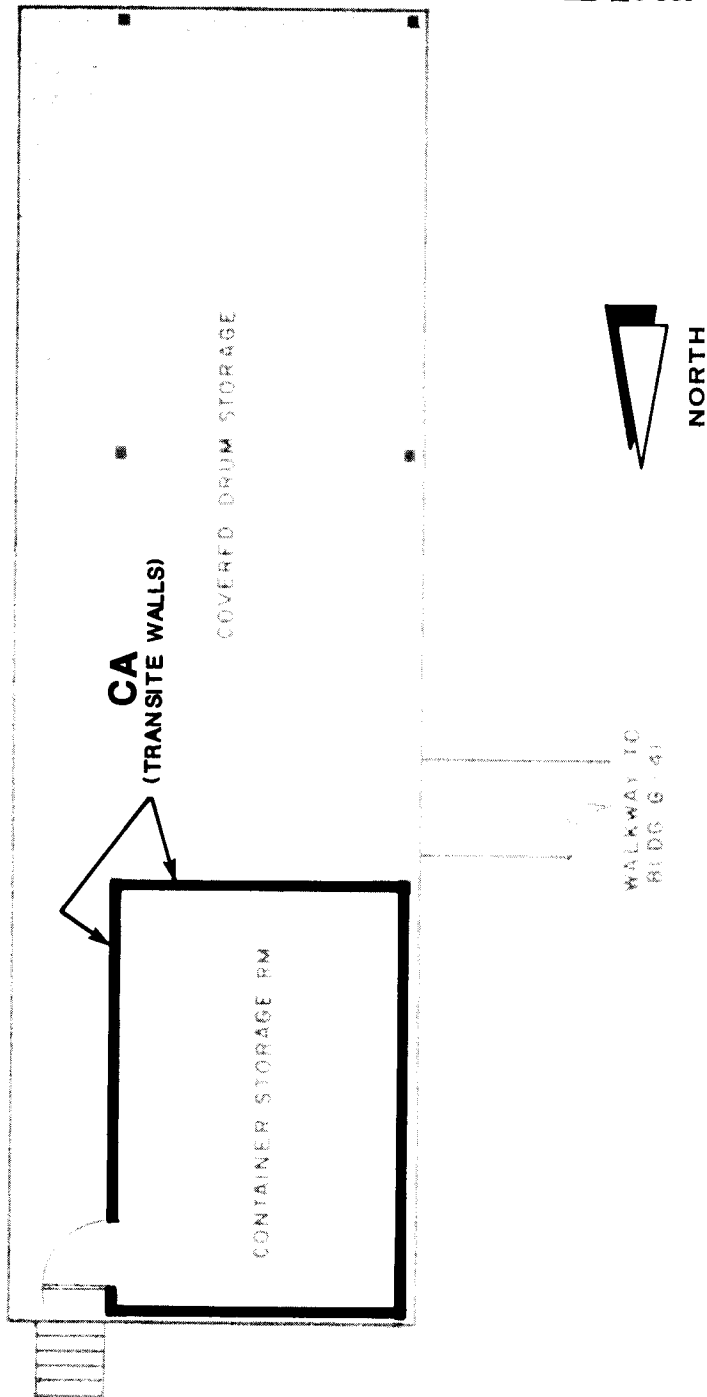
Figure 43. Echo Site: Flammable Drum Storage Building G-44.

Comments: EXTERIOR WALLS ARE TRANSITE AND PAINTED. INTERIOR WALLS EXTEND 4 FEET FROM FLOOR AND ARE TRANSITE. SEE FIGURE 43

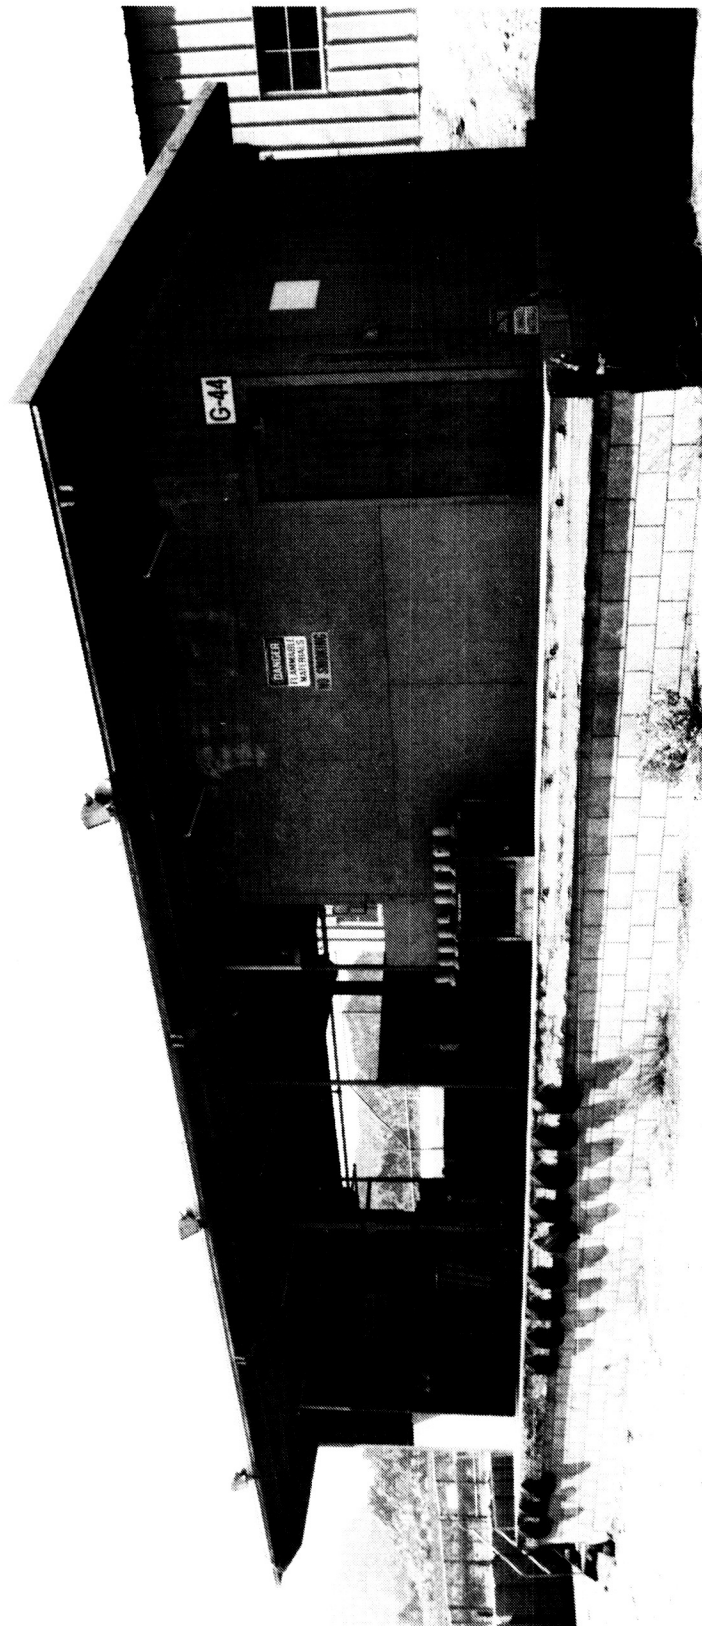
Figure 44. Echo Site: Building G-44, Flammable Drum Storage Shed Constructed with Asbestos-Containing Transite Wall Board.

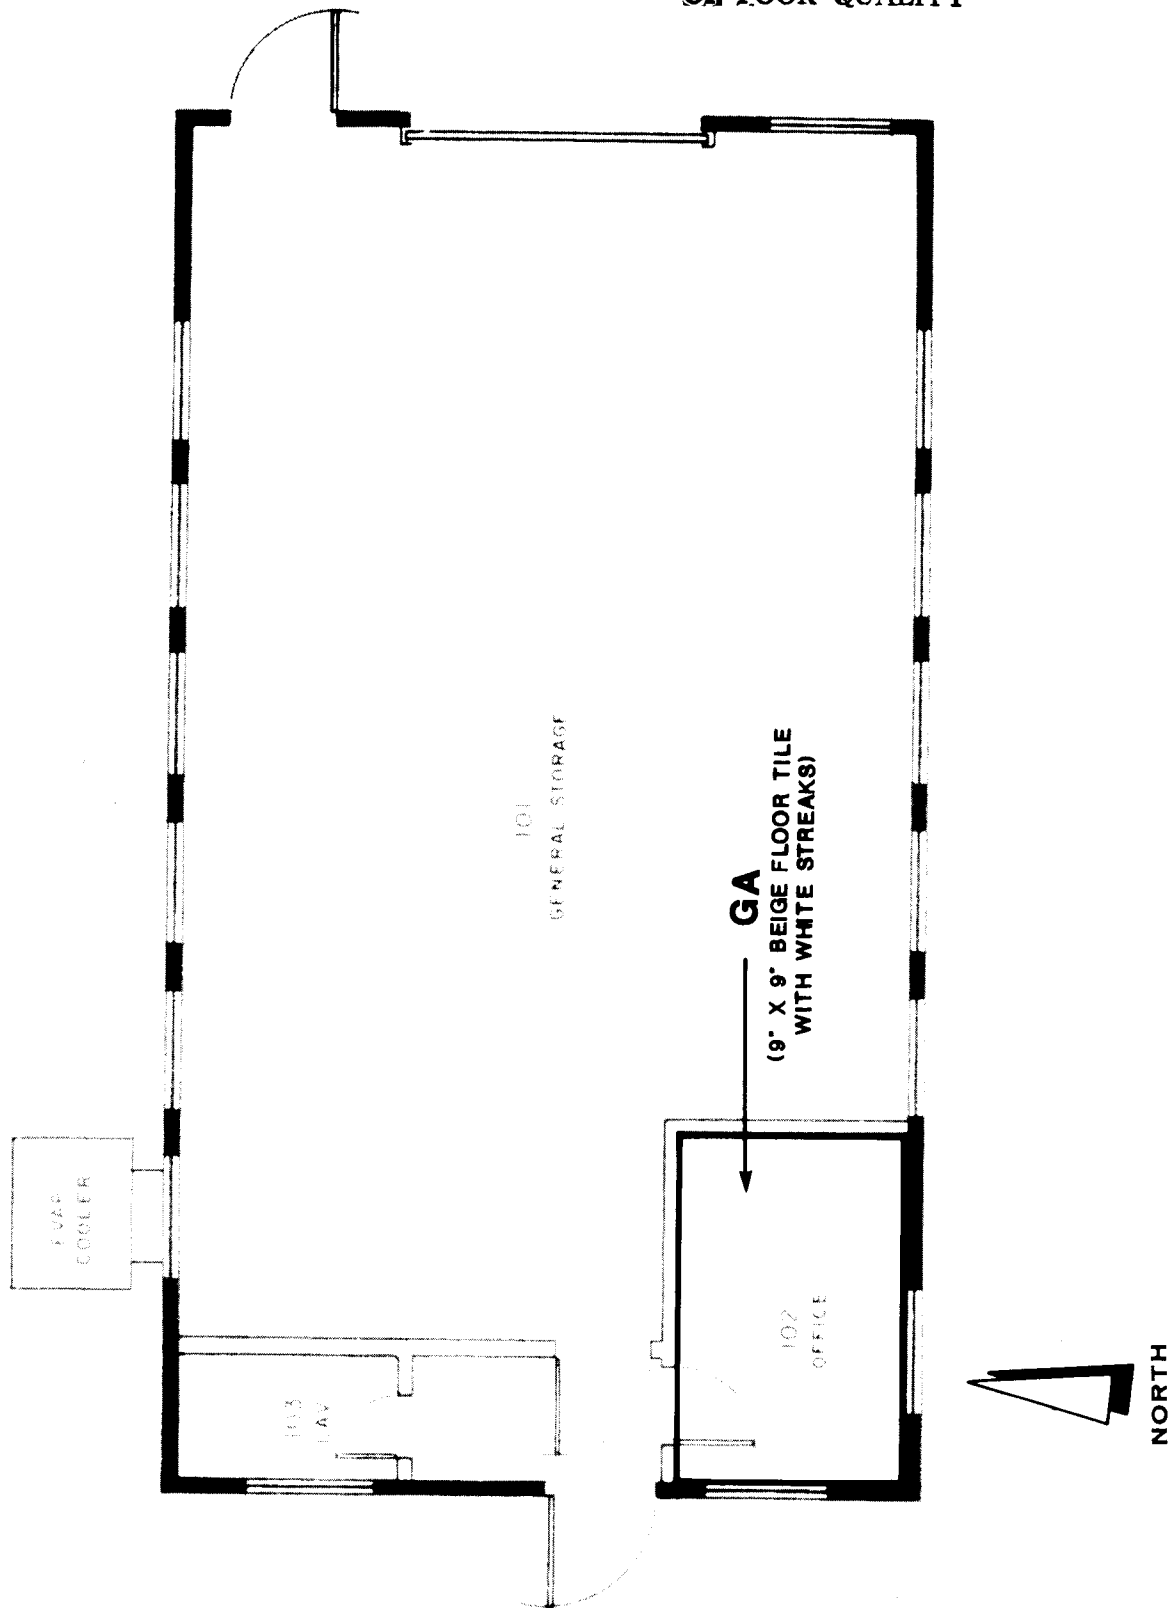
Figure 45. Echo Site: Storage Building G-45.

Comments: 9 X 9 in. BEIGE TILE WITH WHITE STREAKS. SEE FIGURE 45

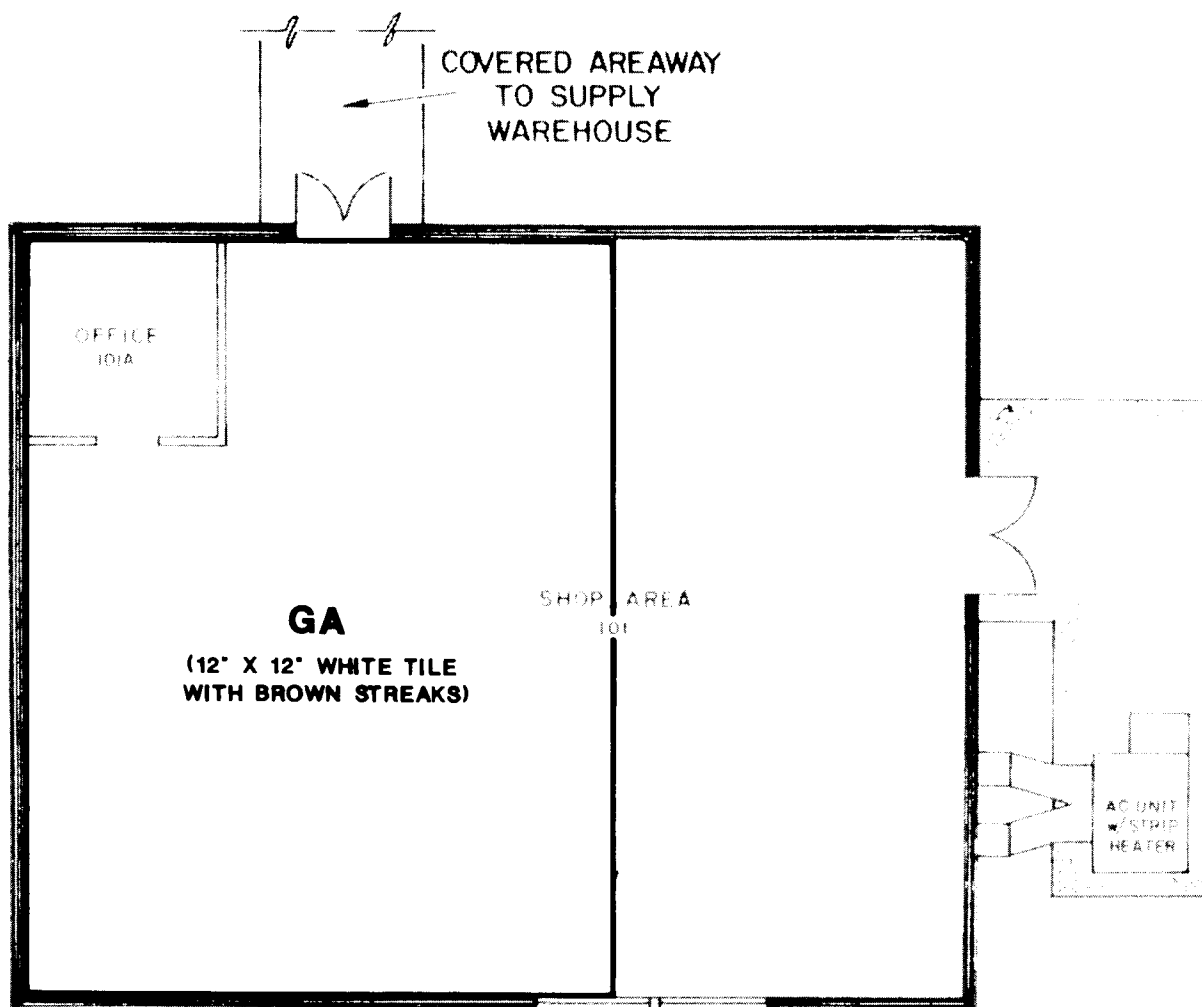
Figure 46. Echo Site: Carpenter Shop Building G-47.

Comments: 12 X 12 in. WHITE TILE WITH BROWN STREAKS. SEE FIGURE 46

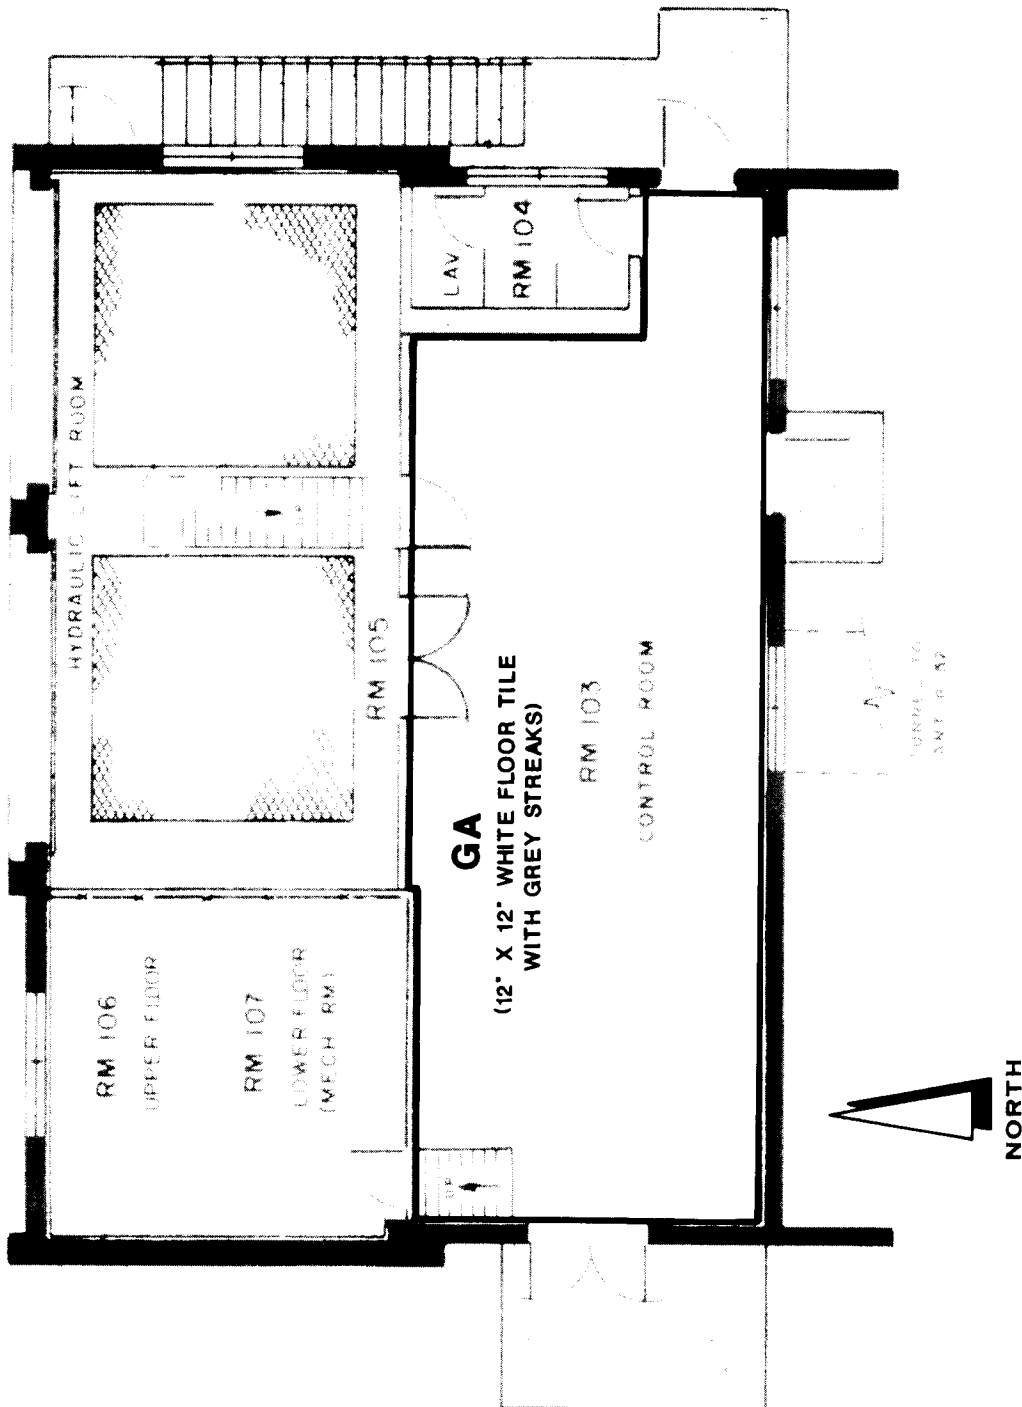
Figure 51. Venus Site: Transmitter Building G-53A.

Comments: 12 X 12 in. WHITE TILE WITH GRAY STREAKS. SEE FIGURE 51

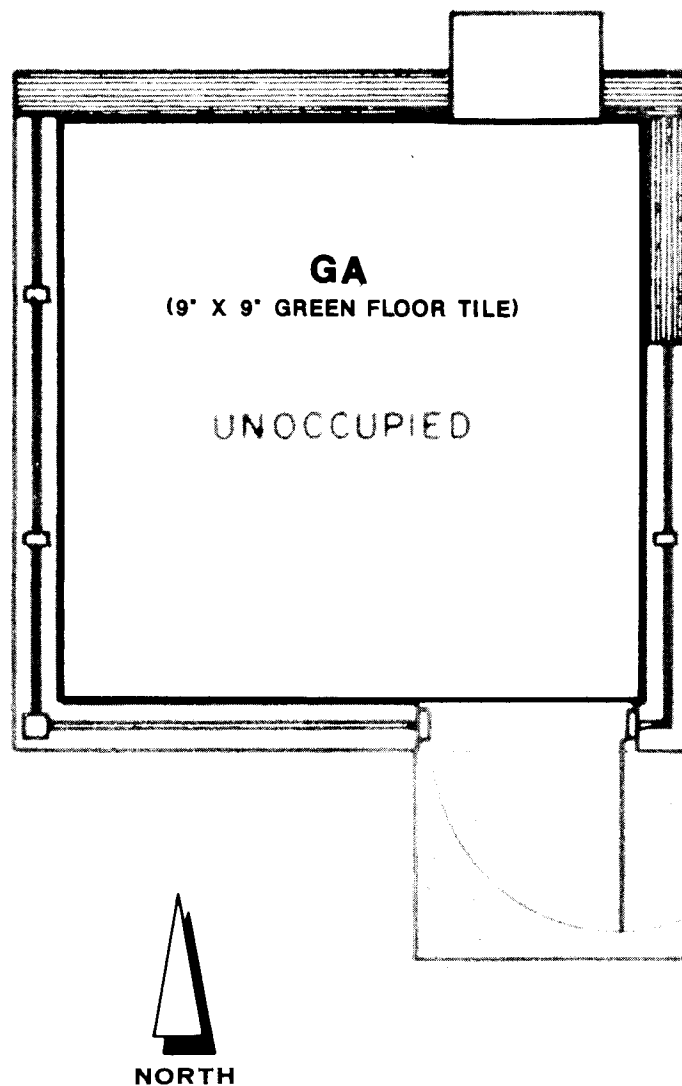
Figure 52. Venus Site: Security Building G-56.

Comments: 9 X 9 in. GREEN TILE. SEE FIGURE 52

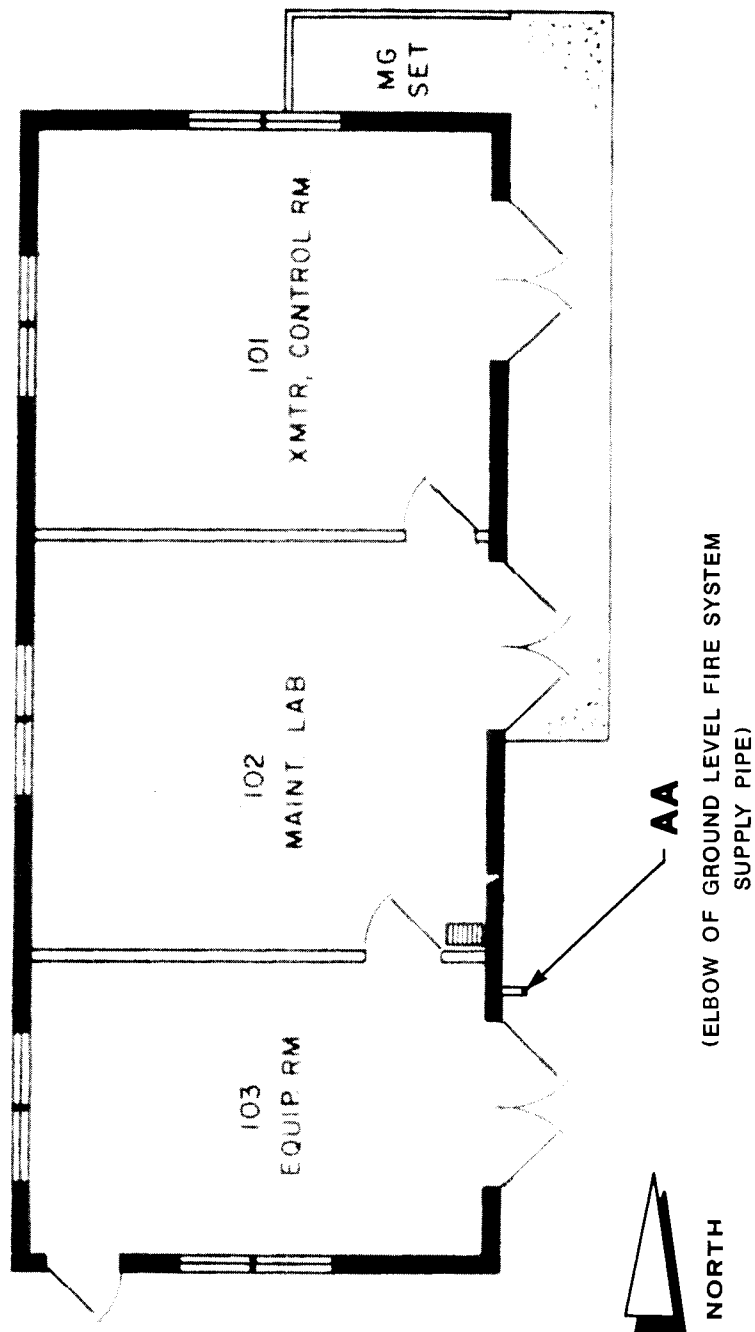
Figure 53. Venus Site: 30' Hydro-Mech and Transmitter Building G-58.

Comments: ELBOW OF HARD CEMENTITIOUS MATERIAL. SEE FIGURE 53

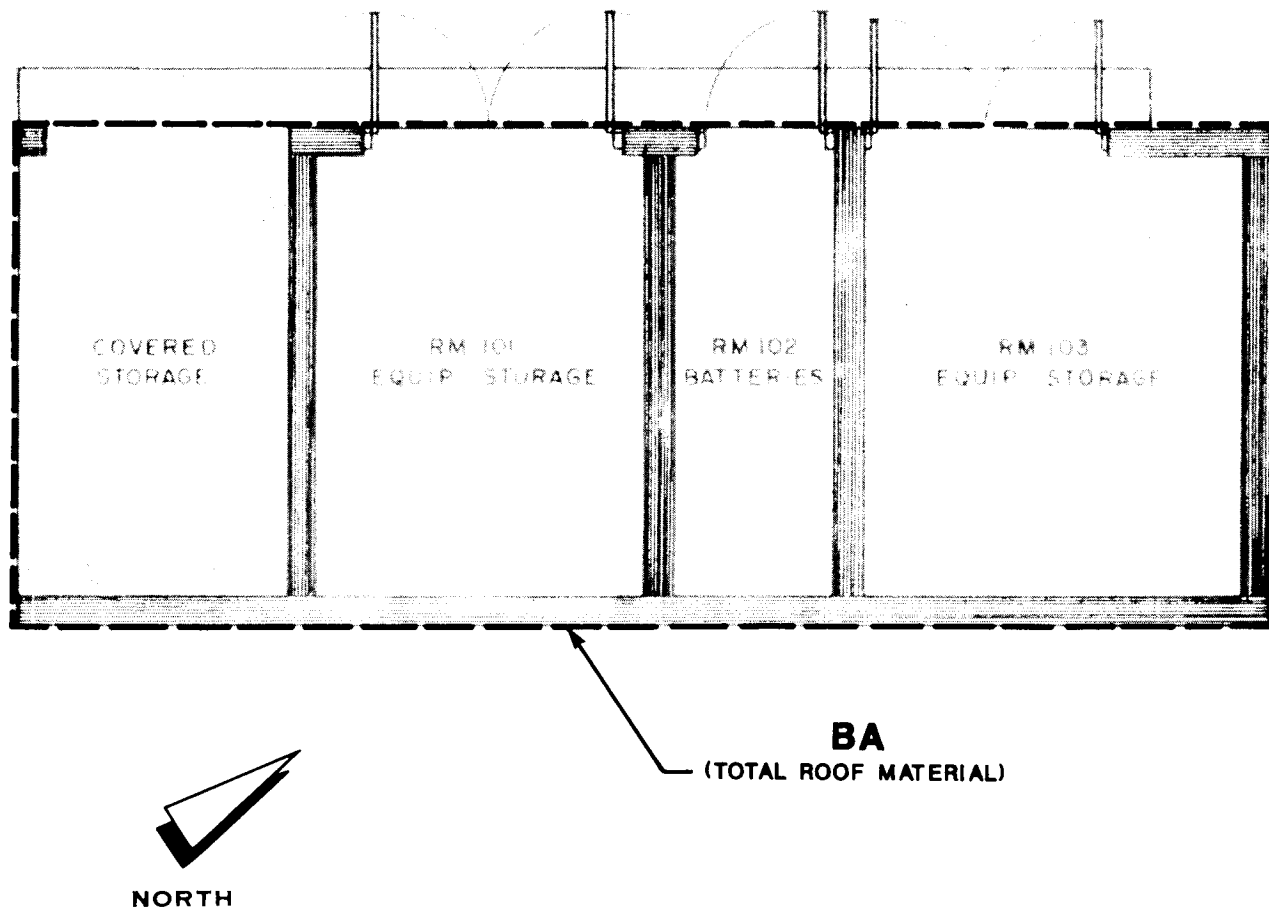
Figure 56. Goldstone Dry Lake Airport: Battery and Portable Generator Building G-70.

Comments: FIBROUS ROOF MATERIAL WITH TAR COATING. SEE FIGURE 56
